Manhole Inspection Summary

Manhole # S47II_054MH

Record Plat: **47II** Node: **054** Status: **Found**

Location Address: **Federal st** Cross Street: **Patterson Park ave**

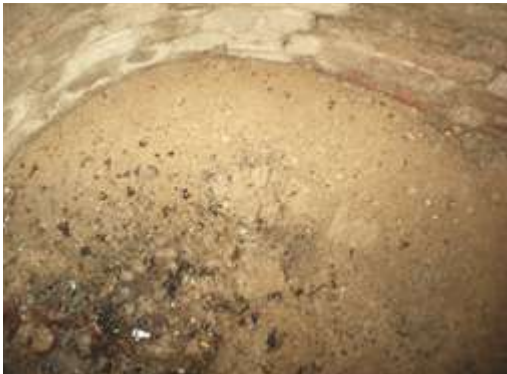
Defect 3

Bench ☒ Exists Material: **Brick** ☐ Parged
Condition: ☐ Sound ☐ Cracked ☐ Root Intrusion ☐ Deteriorated ☐ Leaks ☒ **Debris**

debris

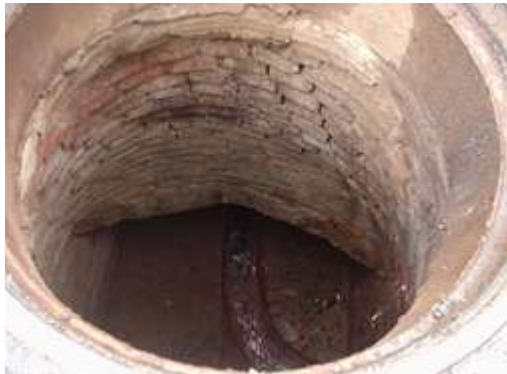
Defect 2

infiltration

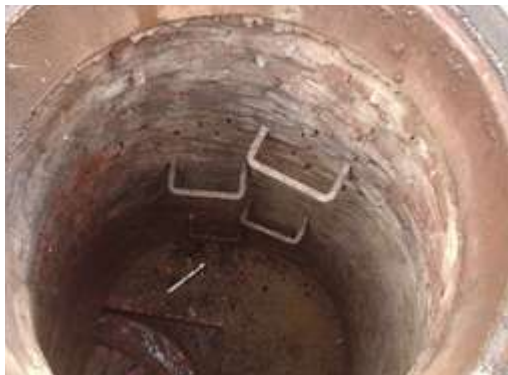
Defect 1

loose brick

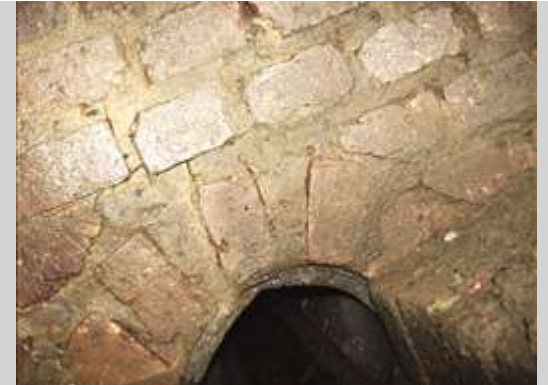
8 in. Circular Gravity Sewer
Pipe Out @ 12 O'Clock

Pipe Height: **12** (in.) Rod and Bar (Angled)
Pipe Material: **Clay** ☐ Pipe Lined
Invert Depth: **9.83** (ft.) Flow Characteristics: **Fast**
Deposits: ☒ None ☐ Mud ☐ Sludge ☐ Debris ☐ Grease
Silt Depth: (in.) Deposits Extent:
Infiltration: **None** Pipe Seal Cond: **Sound**

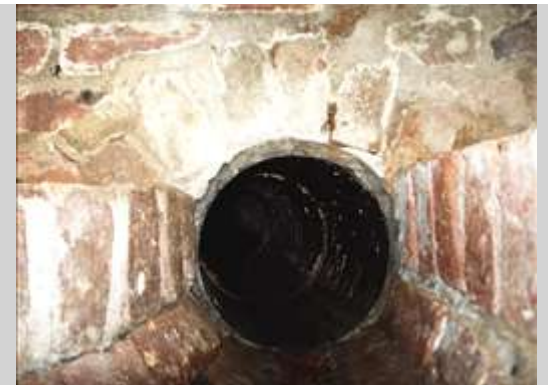
8 in. Circular Gravity Sewer
Pipe In @ 9 O'Clock

Pipe Height: **12** (in.) Rod and Bar (Angled)
Pipe Material: **Clay** ☐ Pipe Lined
Invert Depth: **9.33** (ft.) Flow Characteristics: **Fast**
Deposits: ☒ None ☐ Mud ☐ Sludge ☐ Debris ☐ Grease
Silt Depth: (in.) Deposits Extent:
Infiltration: **None** Pipe Seal Cond: **Sound**

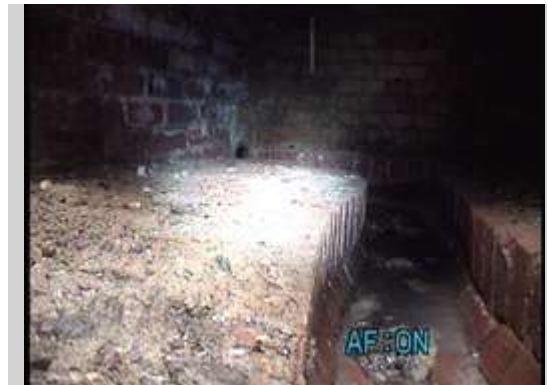
9 O'Clock Inflow
Pipe In @ 9 O'Clock

can not get good pic because recess
